TECHNICAL NOTE No. 842

TIDEWATER AND WEATHER-EXPOSURE TESTS ON METALS

USED IN AIRCRAFT - II

By Willard Hutchler and W. G. Galvin

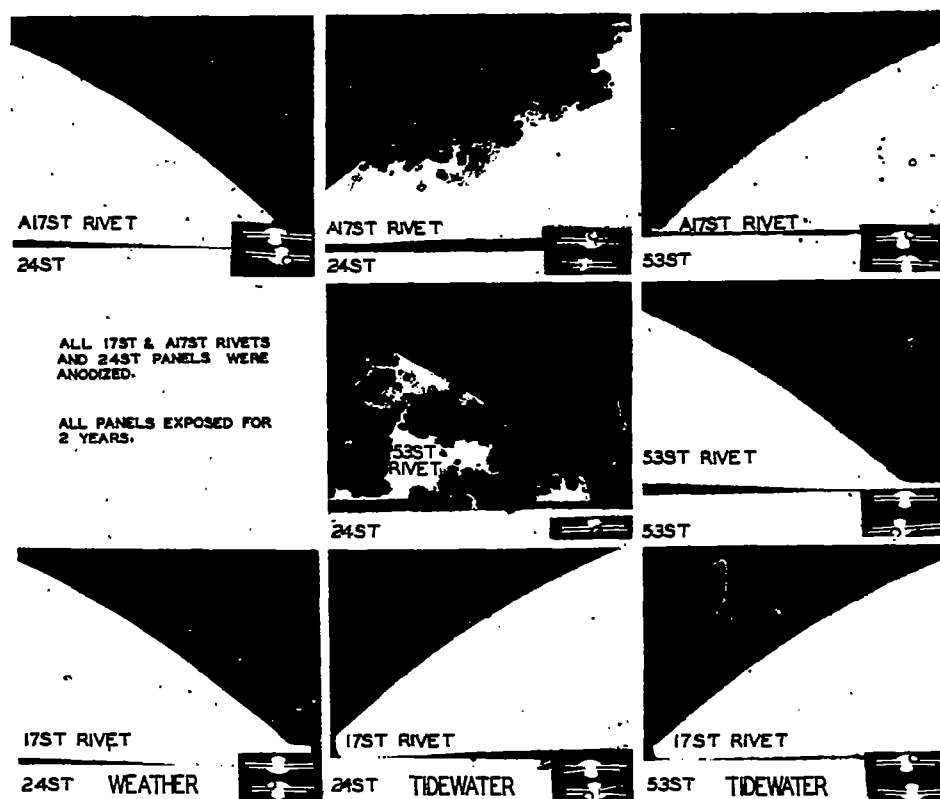
The microscopic examinations confirmed the practical absence of corrosive attack on either the rivets or the sheets where any of the three kinds of rivet were used to join Alclad 24ST, 52S- $\frac{1}{2}$ H, or 53ST (fig. 4) sheet. Such corrosion as occurred seldom exceeded 0.002 inch in depth and was of the pitting type on all the alloys.

Figure 4.- Corrosion on rivet heads and 53ST and anodized 24ST sheets. Attack was especially severe on 53ST and anodized AI7ST rivets joined to 24ST sheet and exposed to tidewater. Photomicrographs, $\times 25$; cross sections (in black rectangles), $\times 1/2$.

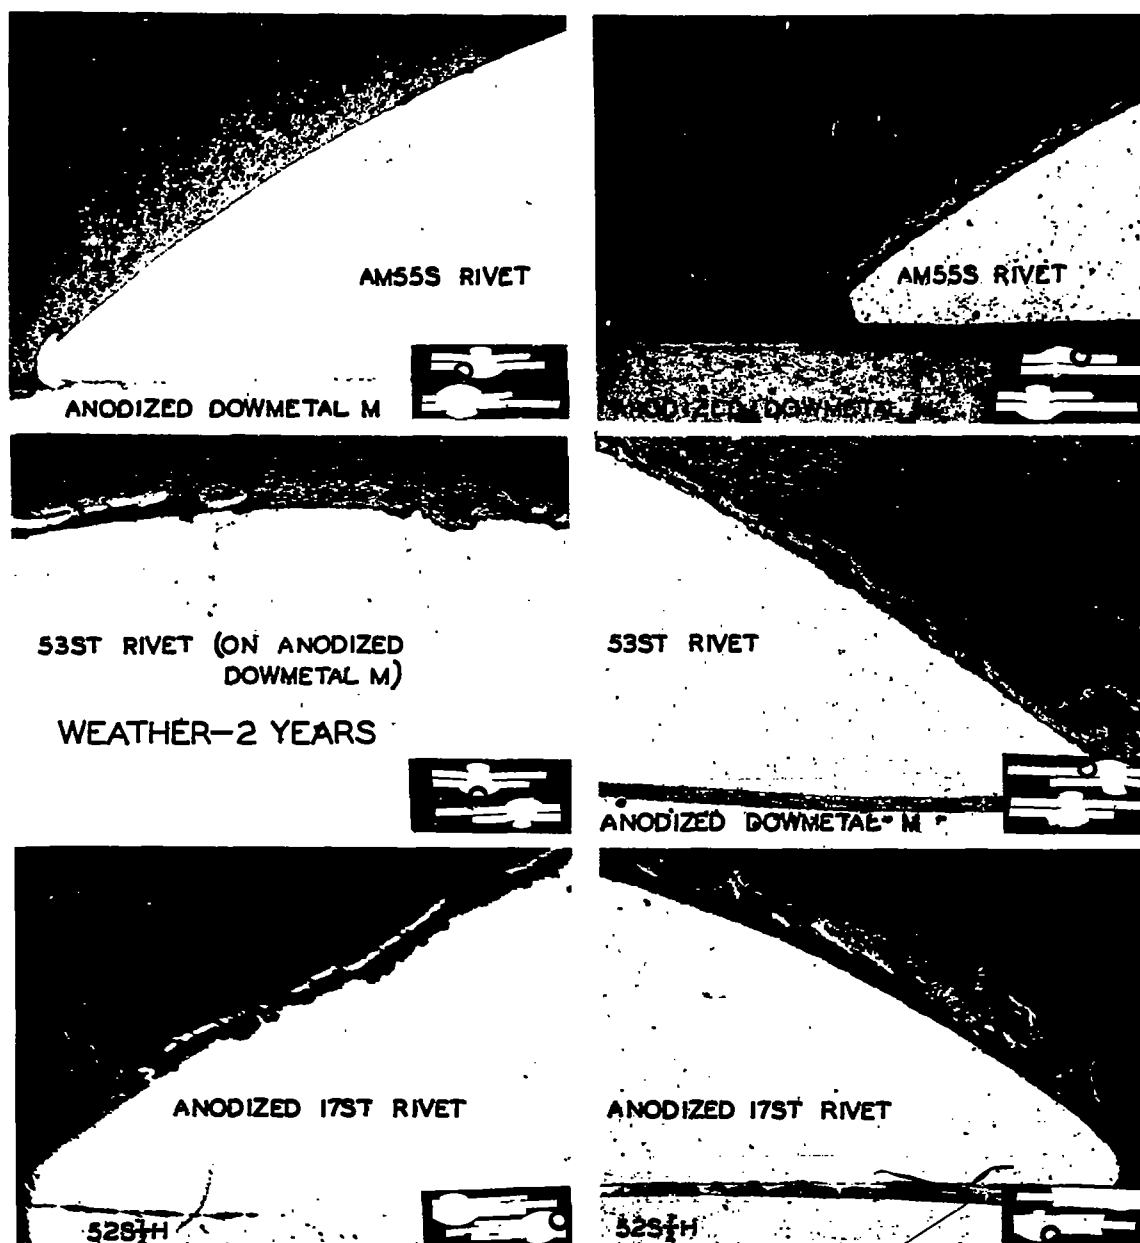
Figure 8.- Corrosion on rivets used for joining Dowmetal M sheets. Attack was least on the unanodized AM55S, intermediate on the 53ST, and most on the anodized 17ST rivets on unpainted panels. None of the rivets on painted panels were corroded. Micrographs, x 40; cross-sections, x 1.

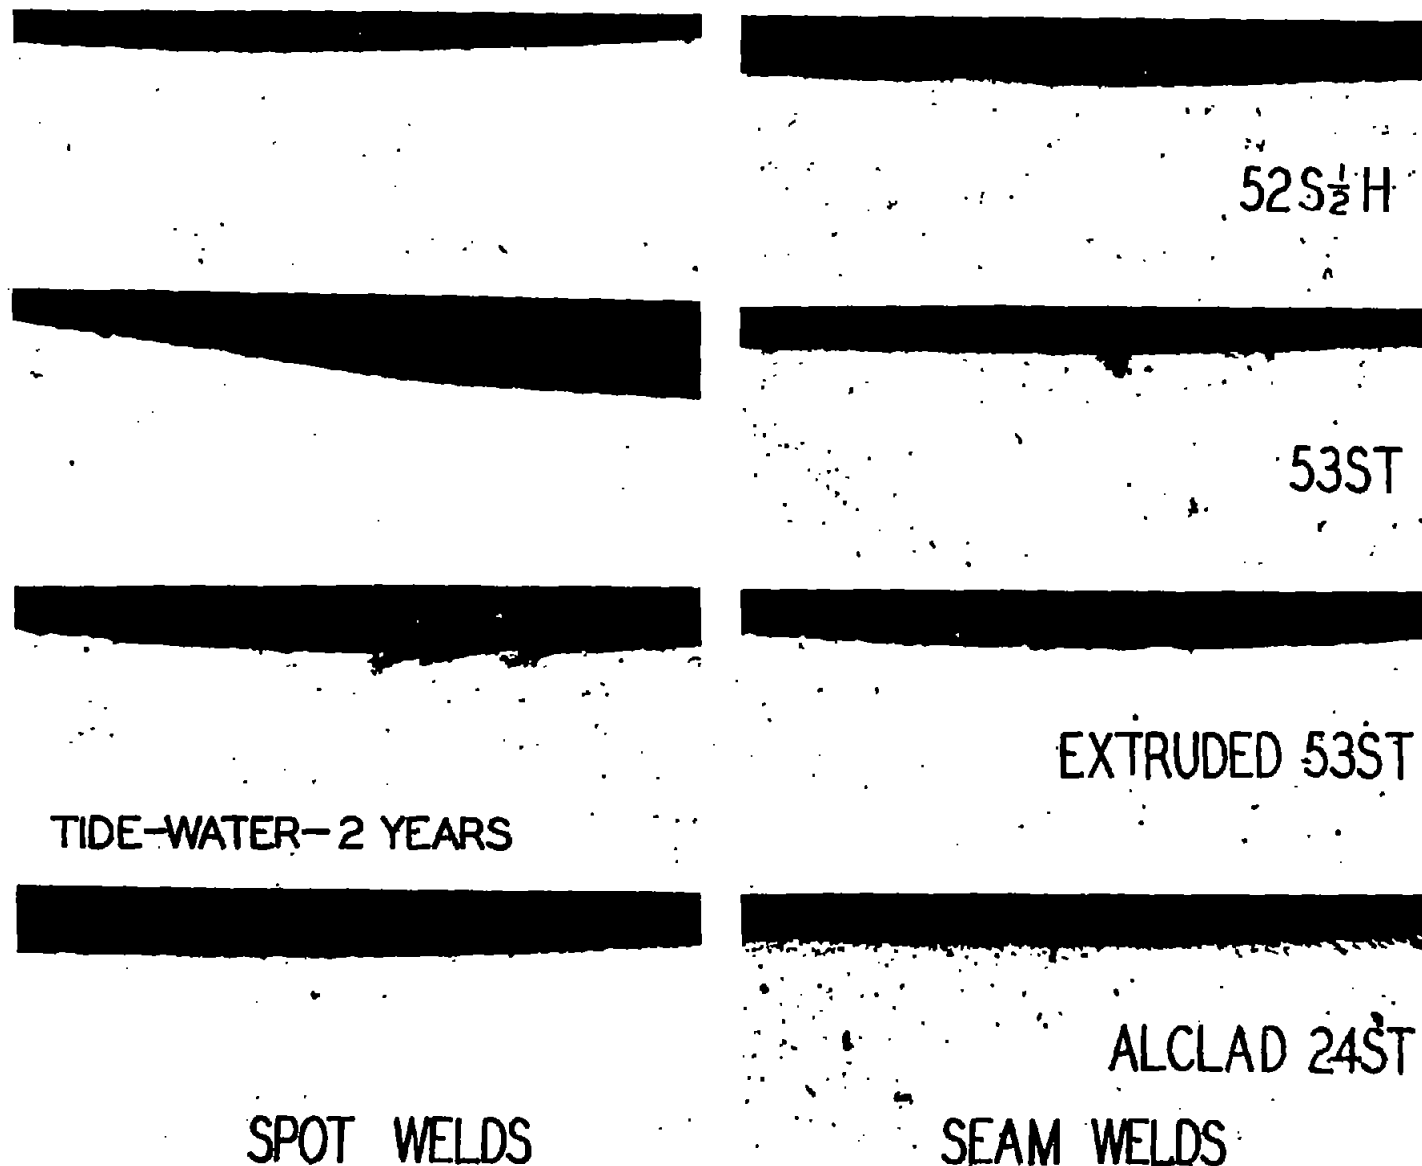
Figure 10.- Microscopic examinations of welds on aluminum-alloy panels exposed to tidewater revealed that corrosion was confined to small isolated areas and that corrosion depth seldom exceeded 0.002 inch, x 50.

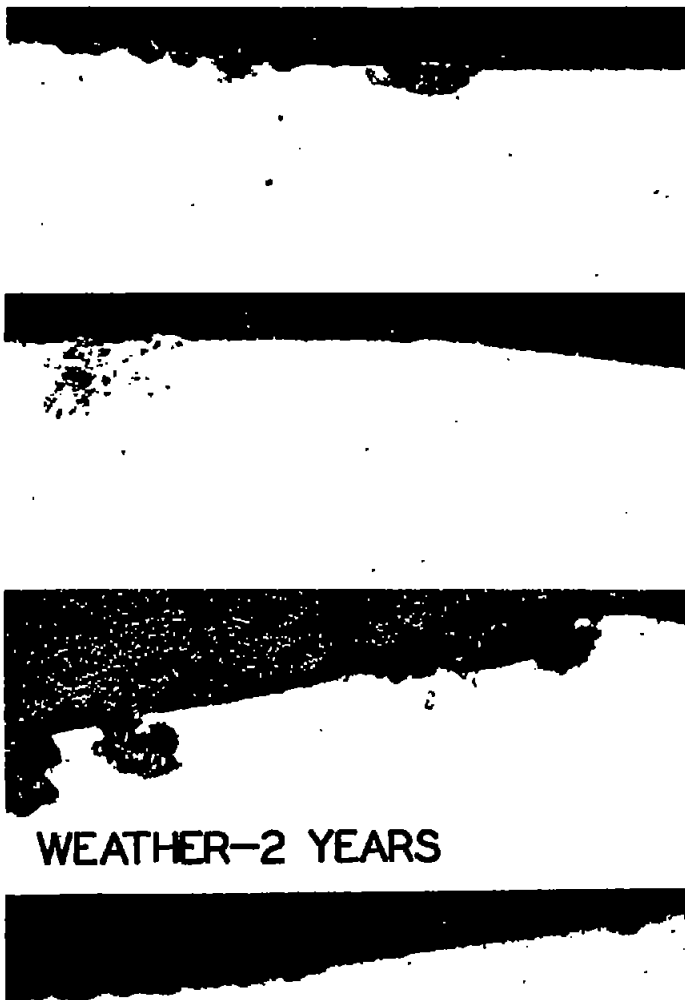
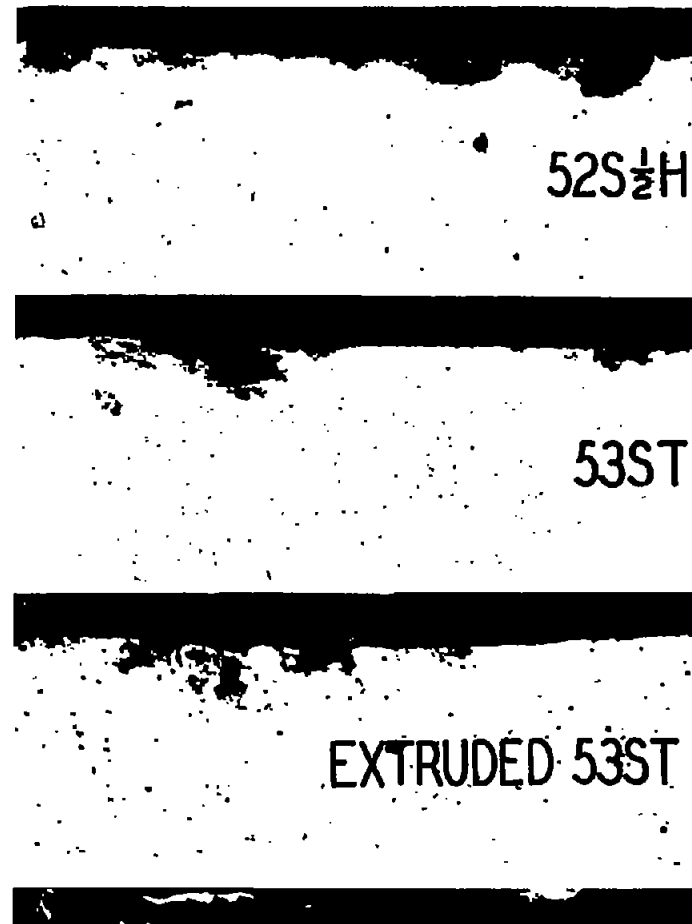
The microscopic examinations (figs. 12 and 13) of the spot welds disclosed many pits (0.001 and 0.002 in.) on the Alclad 24ST panels, but in no case was penetration of the aluminum protective coating found. On 52S- $\frac{1}{2}$ H welds numerous pits were found associated with some intercrystalline attack, generally 0.002 inch deep, but occasionally 0.006 inch. The welds on the sheet and extrusions of 53ST alloy were attacked similarly to those on 52S- $\frac{1}{2}$ H but intercrystalline attack was more in evidence; and occasionally pit depths of 0.010 inch were noted. Little attack occurred at the faying surfaces, but some pits 0.005 inch deep were detected on the 53ST materials.

Figure 12.- Microscopic examination of welds on aluminum-alloy panels exposed to the weather revealed considerable corrosion of greater depth than occurred on unwelded portions. Seam welds were the most severely attacked. Corrosion on welds on Alclad 24ST was

shallower than on the other alloys but penetrated the protective aluminum coating in some instances. x 50.

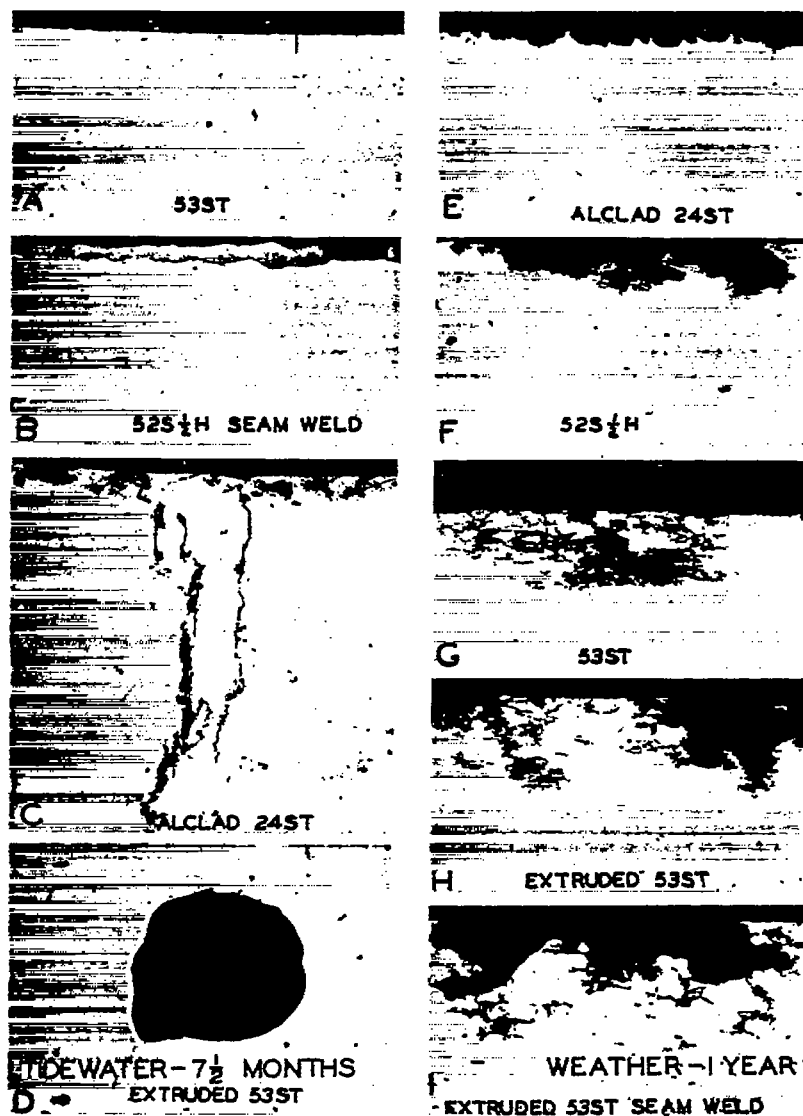
The seam welds were uniformly sound, but cracks occurred on some of the Alclad 24ST spot welds (fig. 13); whereas very small cavities, 0.001 inch in diameter, were present on a few of the 52S- $\frac{1}{2}$ H welds and cavities as wide as 0.010 inch were found in several of the welds on extruded 53ST panels. Numerous cavities, ranging from 0.005 to 0.010 inch in diameter, were found in the gas welds.

Figure 13.- Photomicrographs of welds on aluminum-alloy panels exposed to weather or to tidewater. Spot welds are pictured, unless otherwise noted. A - Formative stage of intercrystalline corrosion. B - Coating on weld, perhaps resulting from reaction with the electrode. C - Cracks present in some of the spot welds in this alloy. D - Cavity, representative of those of average size found in some spot or gas welds. E - Pitting, though general, had not penetrated the aluminum protective coating during the first year. F - Traces of intercrystalline attack were occasionally associated with pits on the 52S-1/2H alloy. G - Intercrystalline corrosion on an area of the sheet remote from a weld. H and I - Intercrystalline corrosion on welds. x 60.

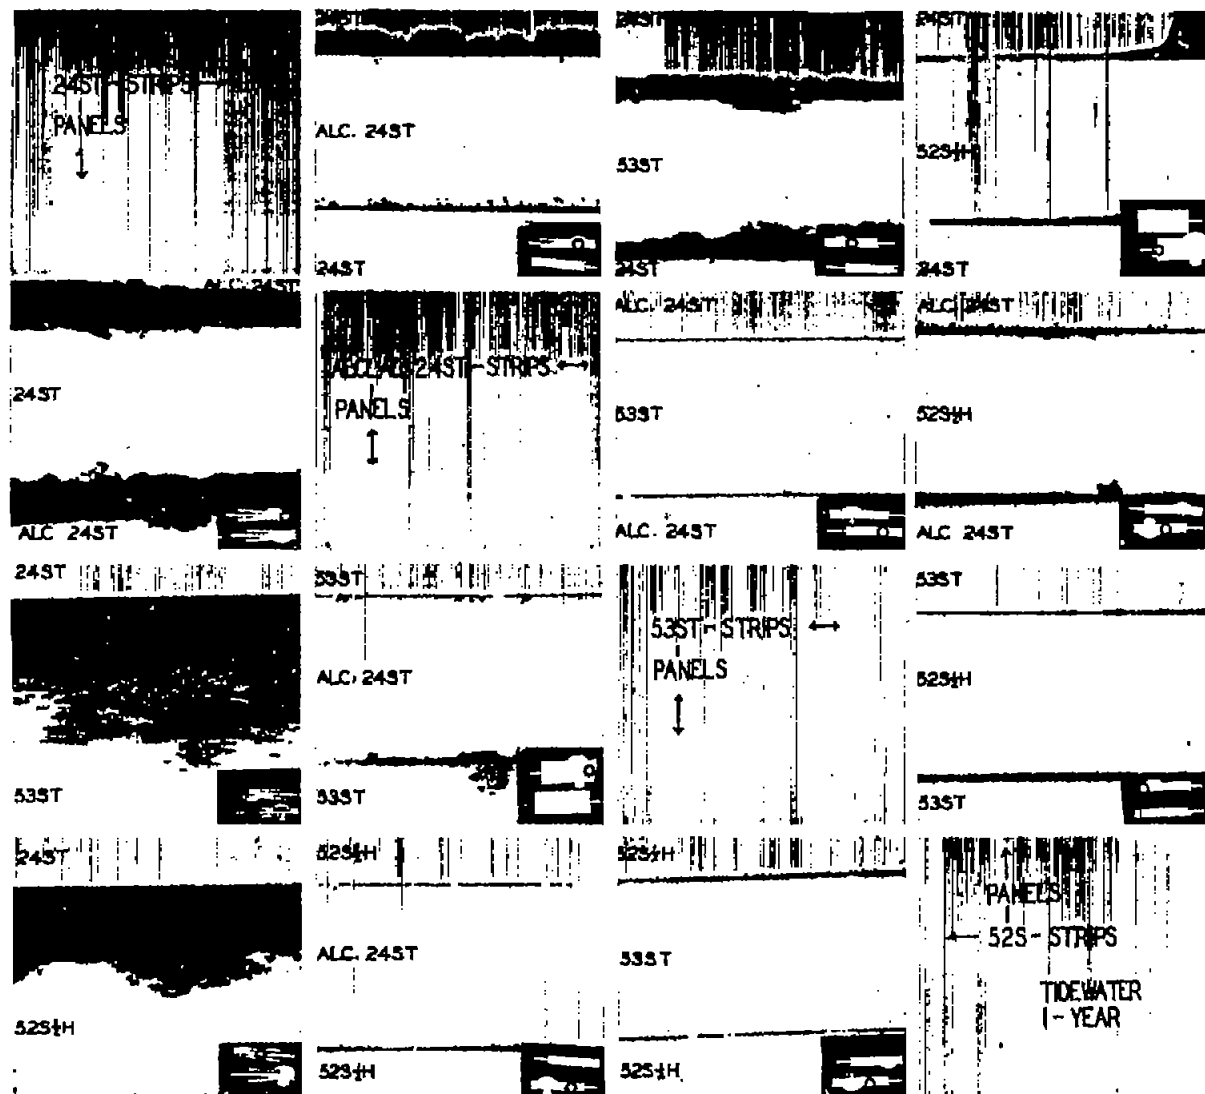
Figure 15.- Cross sections showing aluminum alloys exposed to tidewater in contact with each other. Note that the Al-clad 24ST, 52S-H, and 53ST were anodic to 24ST alloy and were especially severely attacked when 24ST was the main panel. The lack of proximity of strips to the panels, in some instances, is a criterion of the amount of accumulated corrosion products at the faying surfaces which forced the sheets to separate. Photomicrographs, x 25; smaller cross section, x 1/2. (13 and 14).

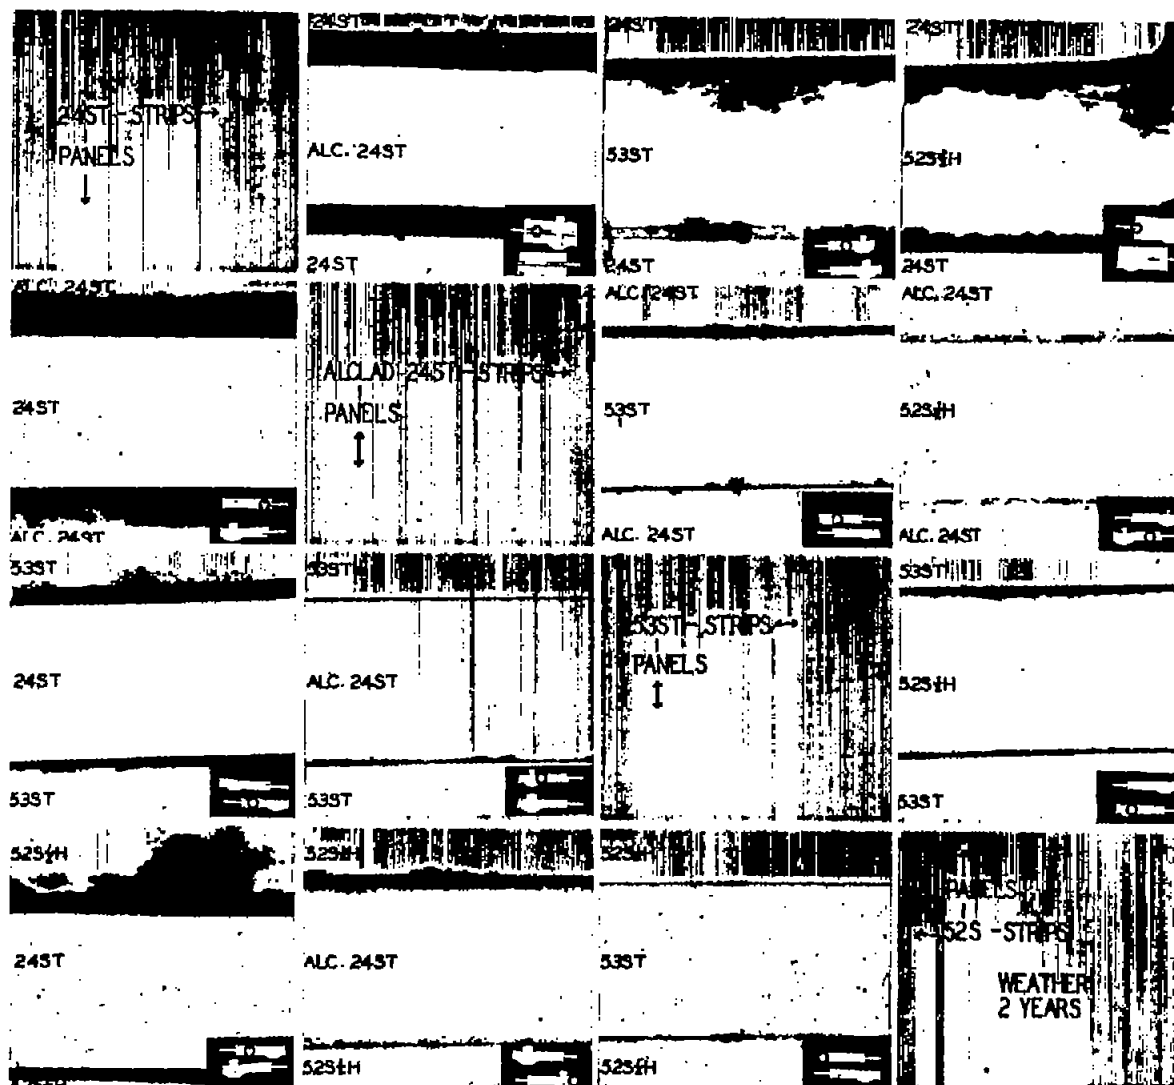
Figure 17.- Cross sections showing aluminum alloys exposed to the weather in contact with each other.

Corrosion owing to electrolytic effects were similar to those observed in the tidewater tests but were usually less severe. Photomicrographs, $\times 25$; smaller cross sections, $\times 1/2$.

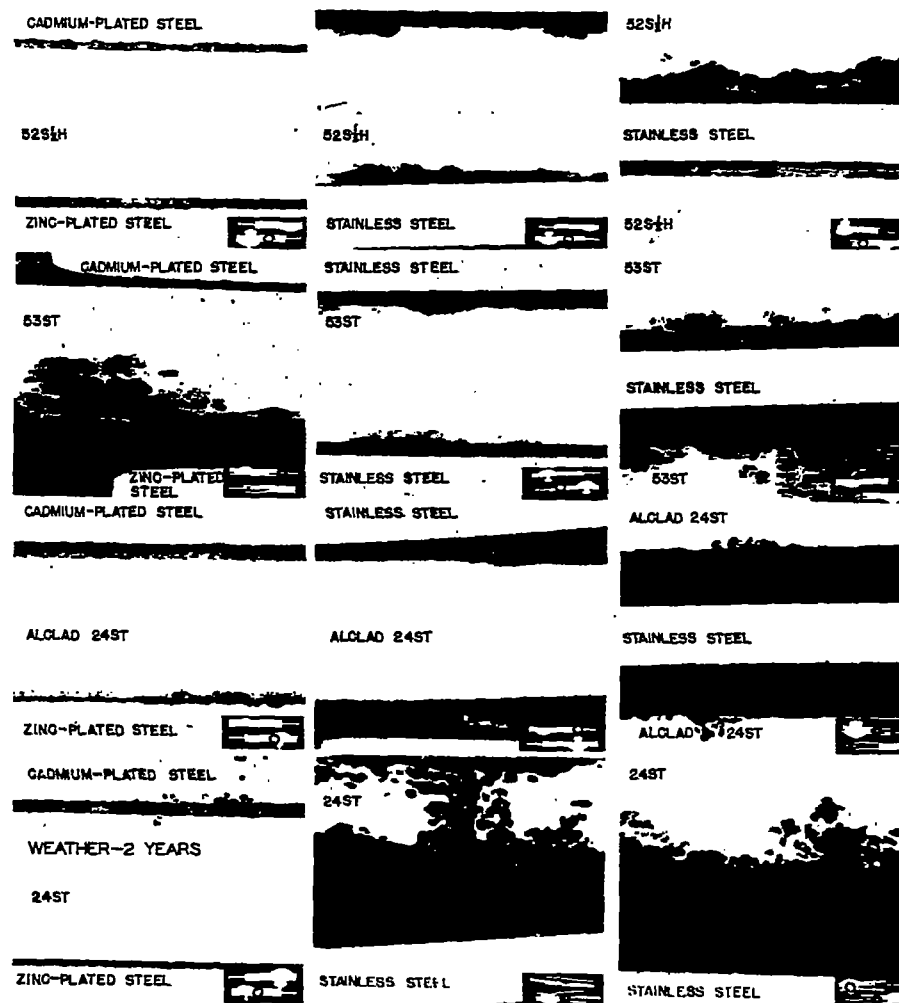
Figure 19.- Cross section showing aluminum alloys exposed to the weather in contact with electrodeposited coatings of cadmium and zinc or with stainless steel. Attack at the faying surfaces was usually deepest on the main panel at areas near the edges of the strips, especially when corrosion products were present in quantity. Photomicrographs, x 25; smaller cross sections, x 1/2.

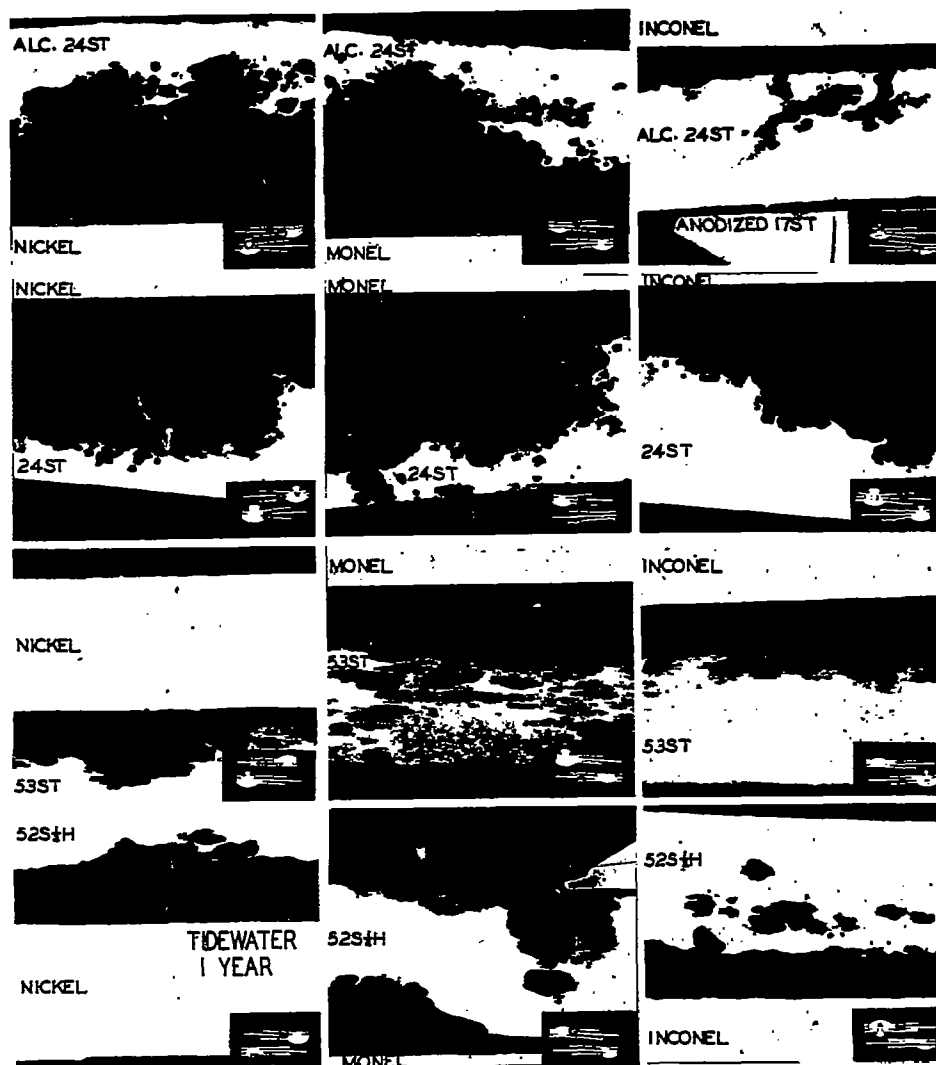
Contacts of aluminum alloys with nickel alloys.-- The aluminum alloys formed the 1- by 4-inch strips attached to main panels of nickel, monel metal, or Inconel. Microscopic examinations of the panels exposed for 1 year to tidewater (fig. 20 and table II) indicated that the aluminum alloys were probably more anodic to the nickel alloys than to the stainless steels. Monel-aluminum alloy couples resulted in the worst corrosion on aluminum, but the corrosion was sufficiently severe with all these combinations to indicate that coupling with these nickel alloys should be avoided. Cracks resulting from the combined action of stresses and corrosion were found on all strips of 24ST and Alclad 24ST in contact with these alloys.

Figure 20.- Cross sections showing nickel alloy panels exposed to tide-water in contact with aluminum alloys. Attack on the aluminum alloys was very severe in every instance. Note the stress-corrosion cracking on the Alclad 24ST strips joined to Inconel (upper right corner). Photomicrographs, x 25; smaller cross sections, x 1/2 (17).

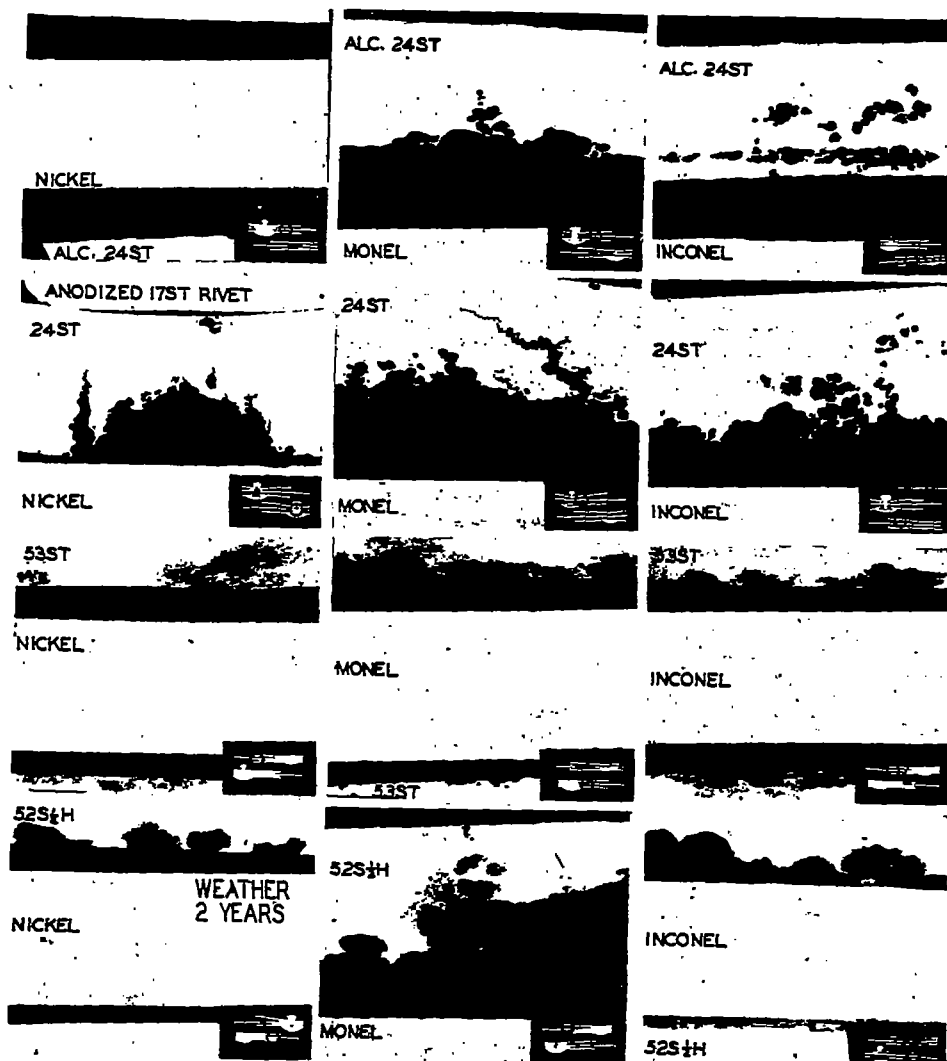
Figure 22.- Cross section showing nickel alloy panels exposed to the weather in contact with aluminum alloys. Compare with Figure 20. Note cracks on 24ST strips in contact with nickel and monel metal. Photomicrographs, $\times 25$; small cross section, $\times 1/2$.

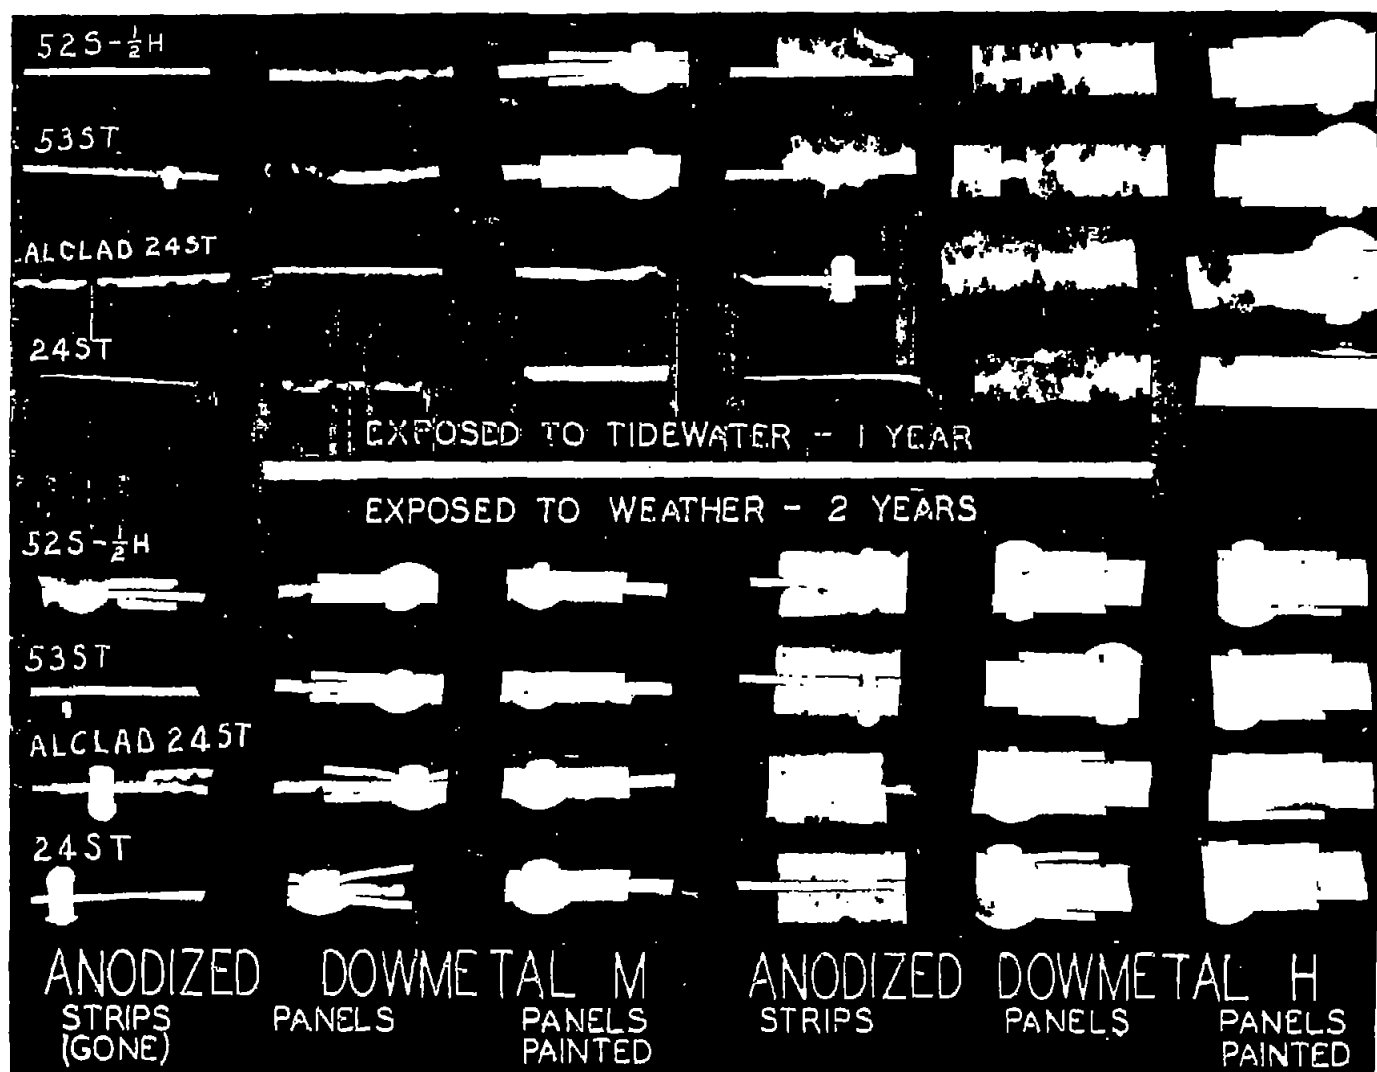
posed to the weather (fig. 23), but the painted panels were in relatively good condition after 2 years (figs. 23, 24, and 25). The panels were painted with 1 coat of Watson Standard Dowmetal Primer No. 1 plus 3 coats of Brooklyn Varnish No. 74 pigmented with $1\frac{1}{2}$ pounds of aluminum paste per gallon. The photographs illustrate that corrosion was much less severe where Dowmetal H, instead of Dowmetal N, was coupled with the aluminum alloys.

Figure 23.- Cross sections showing aluminum alloys exposed to tidewater and to the weather in contact with magnesium alloys. The magnesium alloys were the strips attached to larger areas of aluminum alloys in the first and fourth vertical columns; in the other vertical columns the aluminum alloys were the strips. Panels in the tidewater tests were in advanced stages of disintegration, except when painted. Unpainted panels with Dowmetal M strips were also severely attacked in the weather. x 1 (18).

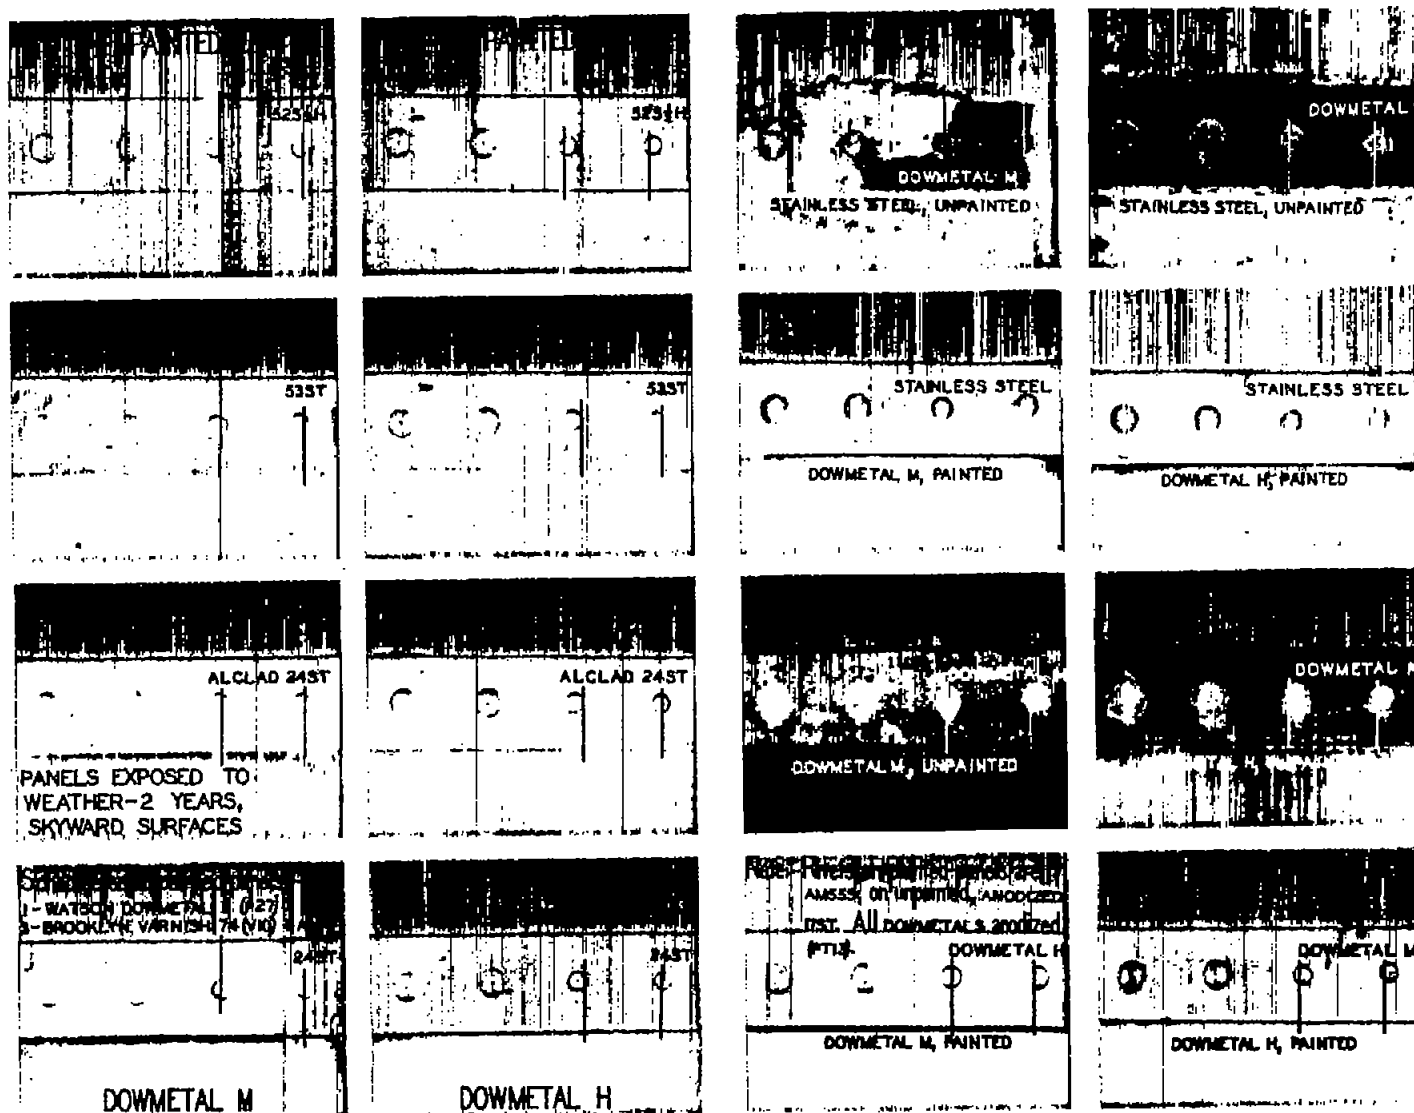
Figure 24.- Surface appearance of panels exposed to the weather with magnesium alloys in contact with each other, with aluminum alloys, or with stainless steel. The painted panels remained in relatively good condition. $\times 1/2$ (19-20).
